# Swift BAT Loop Heat Pipe #0 Temperature Droop Problem and Solution after Its Primary Heater Controller Failure

Michael K. Choi\*

NASA Goddard Space Flight Center, Greenbelt, MD 20771

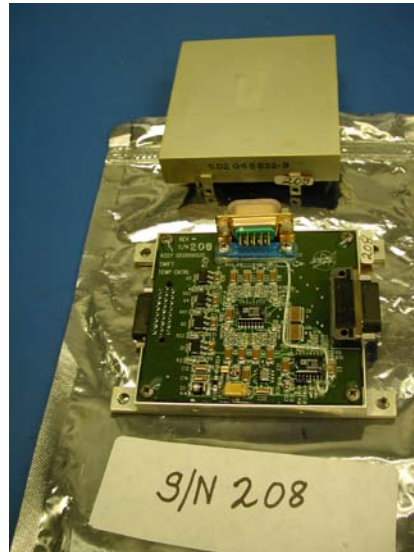
Figure 8. Heater Controller Board.

On March 31 (Day 90), 2010, the primary heater controller of LHP #0 failed. The LHP #0 CC temperature decreased rapidly and activated the secondary heater controller circuit. Note that the primary heater controller is Side A and the secondary heater controller is Side B of the same board (Figure 8).<sup>5</sup> The set point of the secondary heater controller was 6°C, which was 2°C lower than that of the primary heater controller. After the secondary heater circuit was activated, LHP #0 had temperature instability and a temperature droop every orbit (Figure 9). The temperature instability was caused by cold shock and much lower heater controller set point than that of LHP #1. It led to temperature instability on LHP #1 (Figure 10).

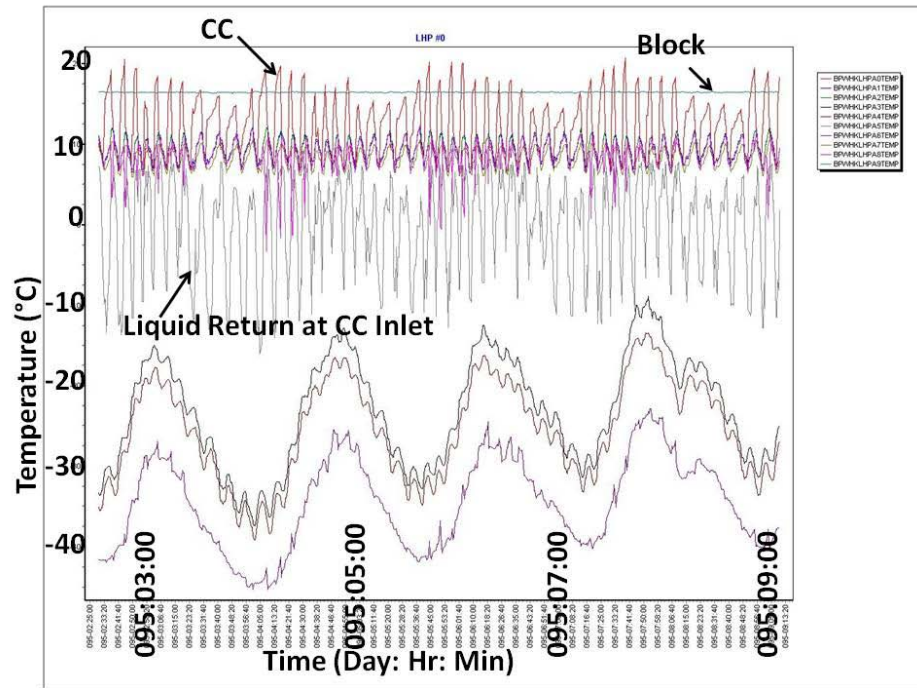
Figure 11. LHP #0 and Block Temperatures on Day 95 (April 5), 2010.

On April 3, 2010, the LHP #0 primary heater controller was disabled and the set point of LHP #0 secondary heat controller was increased from 6°C to 8°C. From the CC temperature in Figure 11, the secondary heater controller had a significantly larger tolerance than that of the primary heater controller in Figure 8. The AD590 temperature sensor for housekeeping telemetry and the thermistor for feedback to the heater controller are both adjacent to the heater (Figure 12). Secondly the temperature of the liquid return at the CC inlet had a wider range than that before the primary heater controller failed. Thirdly the Block temperature was colder than before the heater controller failure. On April 6, a temperature droop occurred. It recovered in one orbit (Figure 13). Also telemetry BPWHLHPA5TEMP violated the alarm low limit. This temperature sensor measures the temperature of propylene liquid at the LHP CC inlet, where liquid returns to the CC from the VCHP heat exchanger (Figures 14 and 15).

It appears that the LHP #0 secondary heater controller set point tolerance was out of specifications. The tolerance in the specifications is no larger than  $\pm 0.25^{\circ}\text{C}$ .<sup>6</sup> Because the heater controller tolerance far exceeded the specification, it had the following consequence. At the coldest attitude and in the eclipse when the temperature of the liquid return from the VCHP heat exchanger to the CC was not sufficiently pre-conditioned, a temperature droop occurred. If the VCHP heater controller is a separate controller (i.e., not a channel of the LHP heater controller), the temperature of the liquid return from the VCHP heat exchanger to the CC could be controlled adequately to prevent a temperature droop. On April 6, 2010, the set point of LHP #0 secondary heat controller was increased to  $8.25^{\circ}\text{C}$ .

On May 10, another temperature droop occurred (Figure 11) and BPWHKLHPA5TEMP violated the alarm low limit again. For each temperature droop, the detector module Block XA1 temperature dropped about 1.5°C, which had no obvious impact on the BAT count rates or detecting GRB. It appears that intermittent temperature droops, once every 10-14 days, occurred at the coldest attitude and during the eclipse.

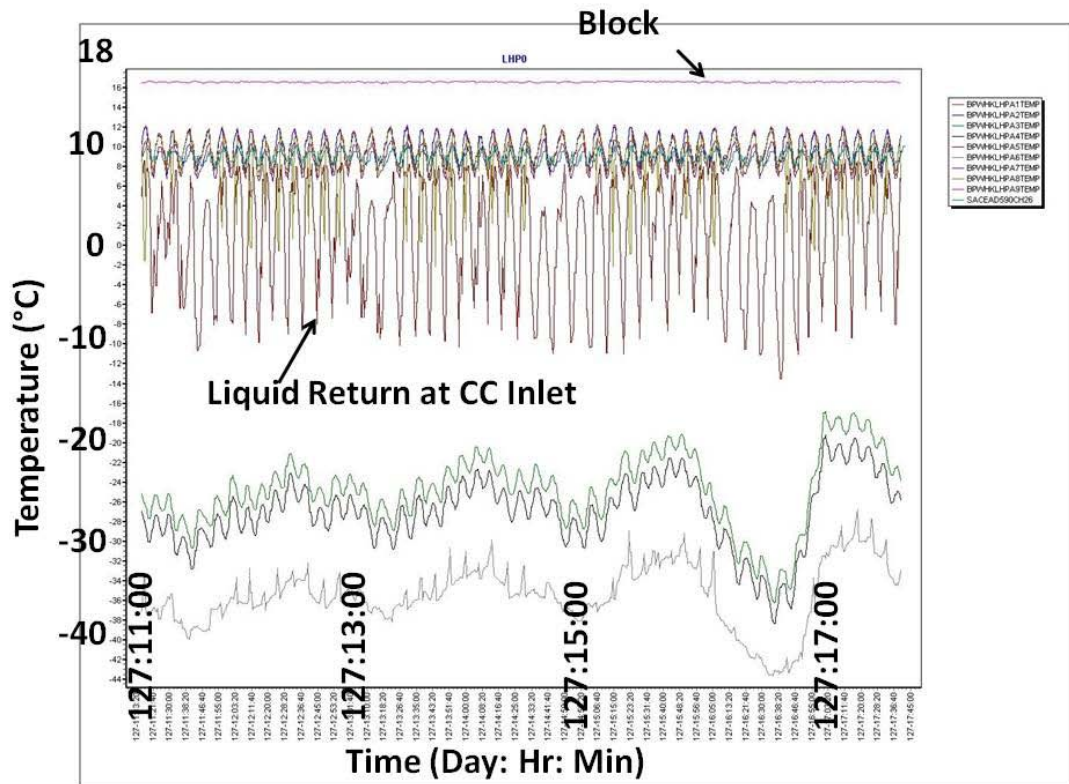
Figure 16. LHP #0 and Block Temperatures on Day 127, 2010.

On April 23, 2010, another temperature droop occurred (Figure 13). Also telemetry BPWHKLHPA5TEMP violated the alarm low limit. The temperature droop recovered in one orbit. For the same reason as the first temperature droop, the set point of LHP #0 secondary heat controller was increased from  $8.25^{\circ}\text{C}$  to  $8.5^{\circ}\text{C}$ . Afterward the liquid return at CC inlet temperature still had a significantly wider range than that before the March 31 primary heater controller failure (Figure 16). Also the Block temperature was still slightly colder than that before the March 31 primary heater controller failure. Figure 17 displays the temperature range of telemetry BPWHKLHPA5TEMP before and after the primary heater controller failure. It can be seen that it is about  $13^{\circ}\text{C}$  wider after the primary heater controller failure.

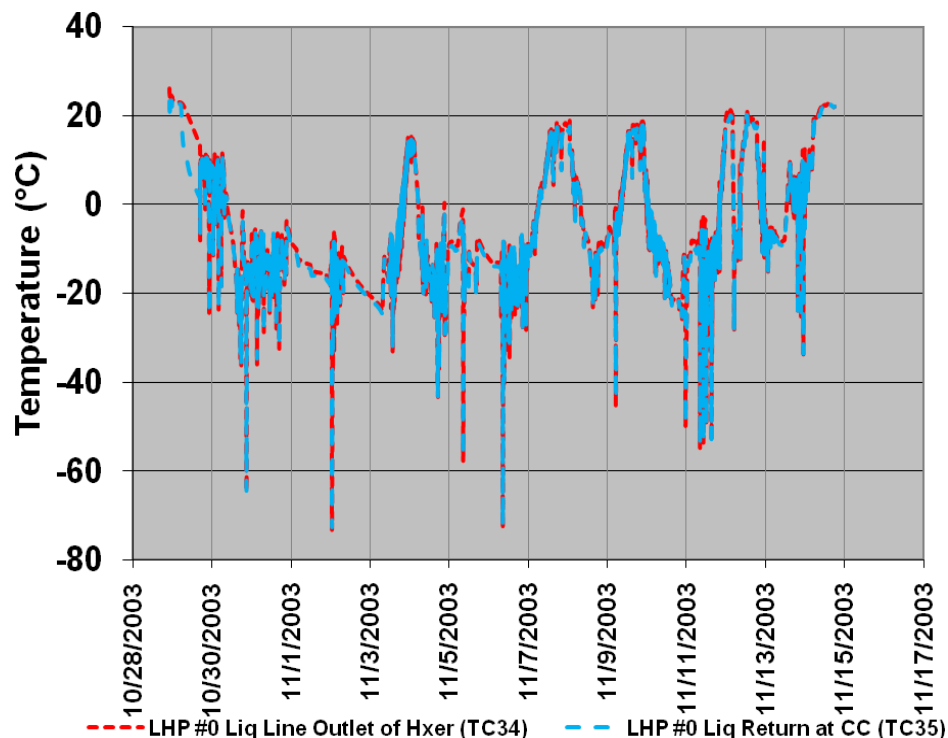
**Figure 18. LHP #0 Liquid Return at CC Inlet Temperature in BAT T/V Test.**

During the BAT integration and testing (I&T), the BPWHKLHPA5TEMP low alarm limits were set to -25°C for yellow and -30°C for red. These limits were intended to alarm non-nominal LHP operation. A thermocouple (TC35), adjacent to BPWHKLHPA5TEMP, was used in BAT instrument level thermal balance (T/B) and thermal vacuum (T/V) cycling tests. Also a thermocouple (TC34) was used to monitor temperature of liquid line outlet of VCHP heat exchanger. The test results show that TC34 and TC35 temperatures are nearly the same and the coldest temperature of TC34 or TC35 in tests is -70°C (Figure 18). On May 17, 2010, the BPWHKLHPA5TEMP alarm low limits for flight operation were changed to -35°C yellow and -40°C red. This change was intended to prevent alarms caused by temperature droop.

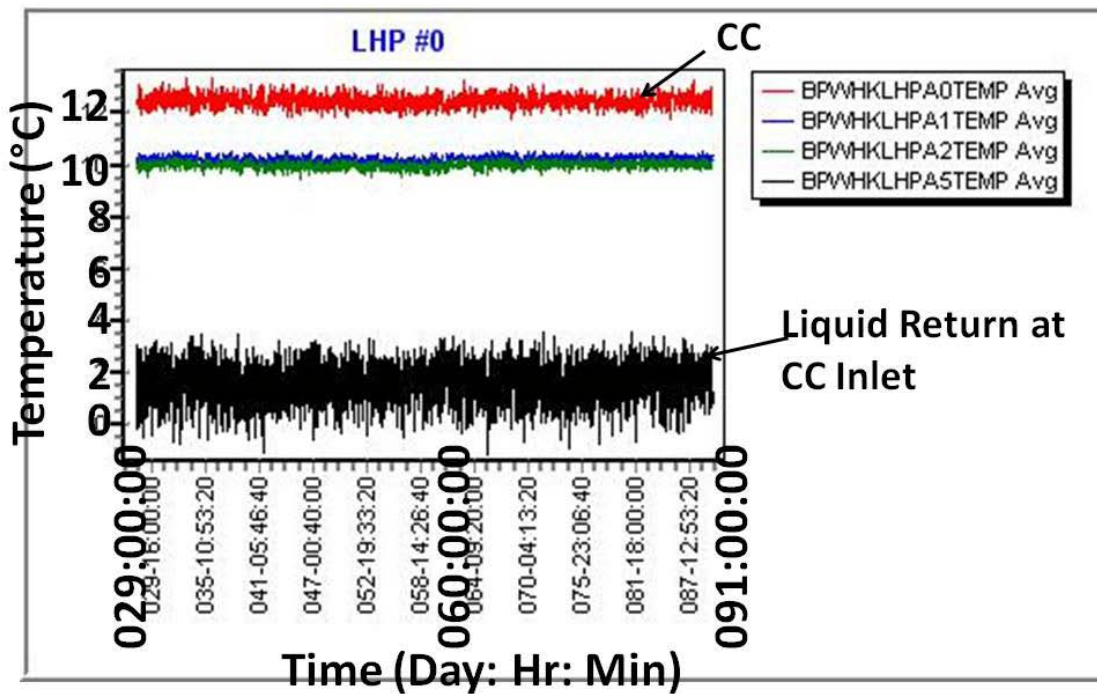
Figure 20. LHP #0 Temperature from Day 28-91, 2011.

As of April 4, 2011, LHP #0 is still operating and the BAT continues detecting GRB. Figure 20 shows the temperatures of the LHP #0 from January 28-April 1, 2011. There was no temperature drop during that 62-day period.
